भारत सरकार/ GOVERNMENT OF INDIA
पत्तन, पोत परिवहन और जलमार्ग मंत्रालय
MINISTRY OF PORTS, SHIPPING AND WATERWAYS
नौवहन महानिदेशालय, मुंबई
DIRECTORATE GENERAL OF SHIPPING, MUMBAI

DGS Circular 01 of 2025

Casualty Branch Circular – 01 of 2025

Sub: Fatality on board a tanker while undergoing repairs at berth

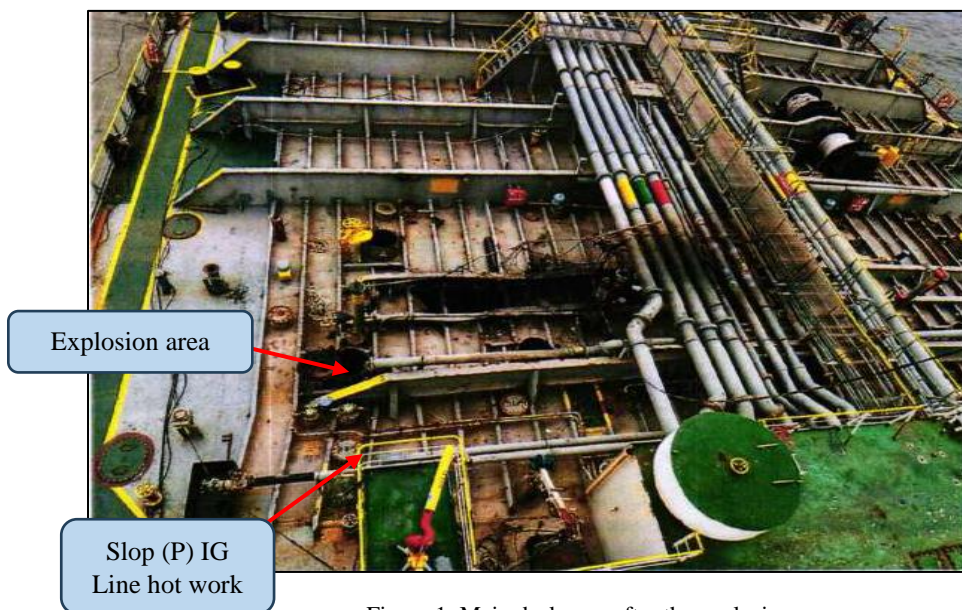
This circular is issued to highlight a recent unfortunate incident on an Indian-registered oil tanker at an Indian port which was berthed at layup berth for repair, which tragically resulted in the loss of one life and injuries to three shore-contracted personnel on board. The casualties occurred due to an explosion inside the port-side Slop tank while cutting of nuts and bolts, using hot work, was being carried out on the Inert Gas line at the main deck.

Figure 1: Main deck area after the explosion

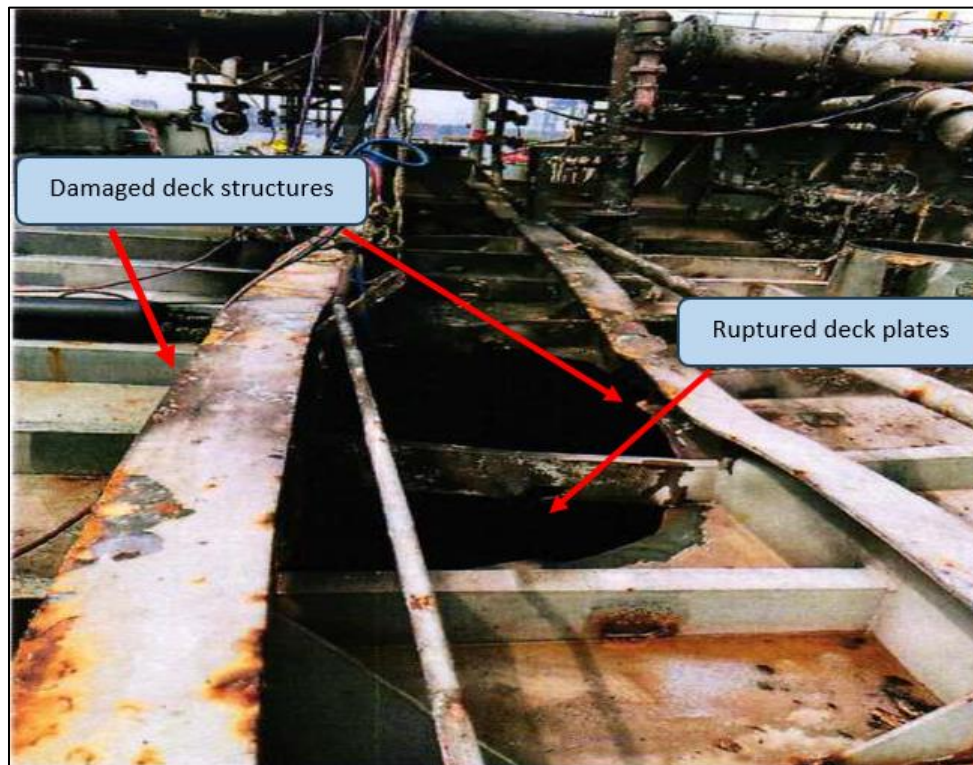
Figure 2: Damaged structural members on main deck

On 10th November 2023 at 0005 hrs. there was an explosion followed by fire on the tanker while the repairs were being carried out near the vicinity of Slop tank (port) which led to the fatality of one shore personnel and injuries to three others from the shore team. The vessel's tank dome and the internals of the Cargo Oil Tank No.7 (port) and Slop tank (port) were damaged and the main deck plating between Frame No. 49-50 were badly ruptured. There was no report of environmental pollution following the casualty or damage to the Port infrastructure following the incident.

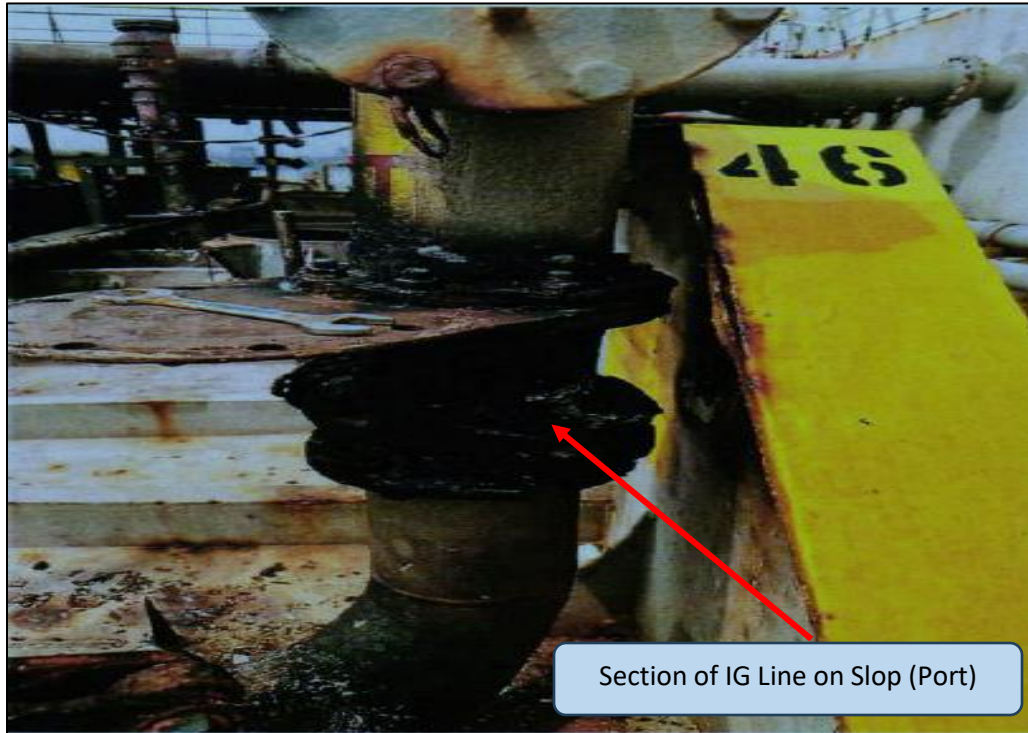
Figure 3: Section of Inert Gas line where unscheduled job was carried out

carried out 03 cycles of washing which were of 45 Minutes duration each, in-adequate isolation of Inert Gas line also contributed towards accumulation of gases in the inert gas pipeline.

When performing hot work or any maintenance on systems connected to potentially hazardous areas like Slop tanks, it is essential to ensure that all pipelines, inlets, and tank domes are properly closed or isolated before starting work. This is to prevent dangerous atmospheric conditions, such as flammable gases or lack of oxygen, from affecting the workspace. Leaving tanks open to the atmosphere, especially when connected to other systems (such as IG piping), creates a high-risk environment that could lead to serious safety incidents.

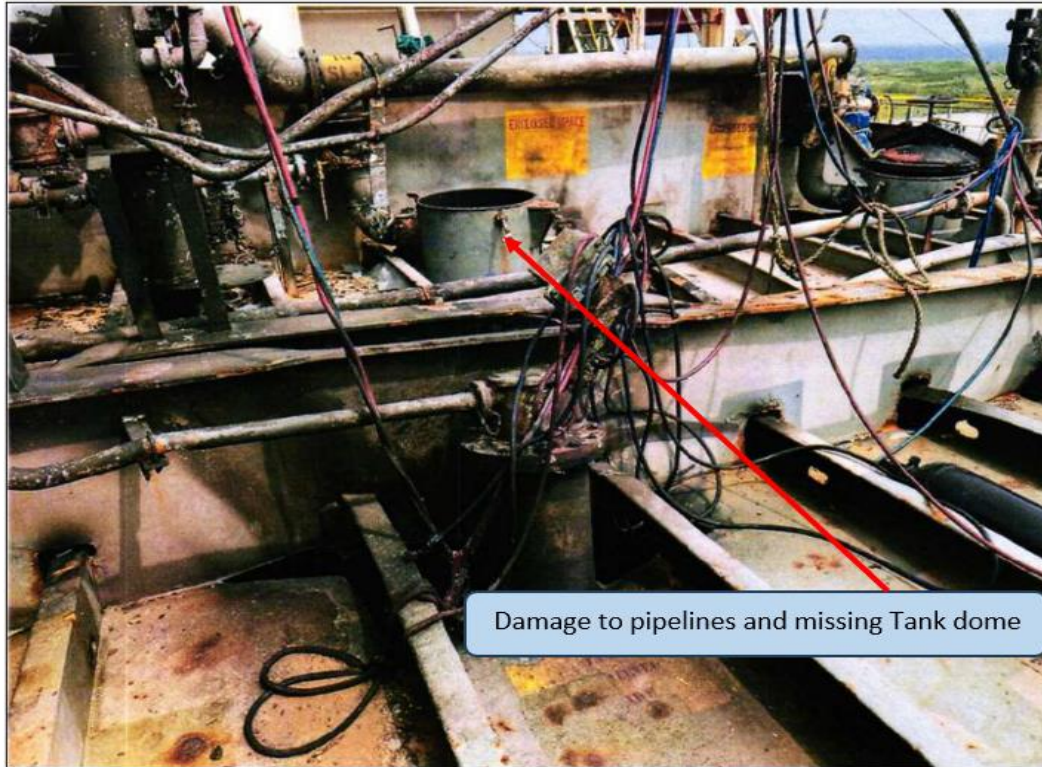
Figure 4: Extent of damage on main deck

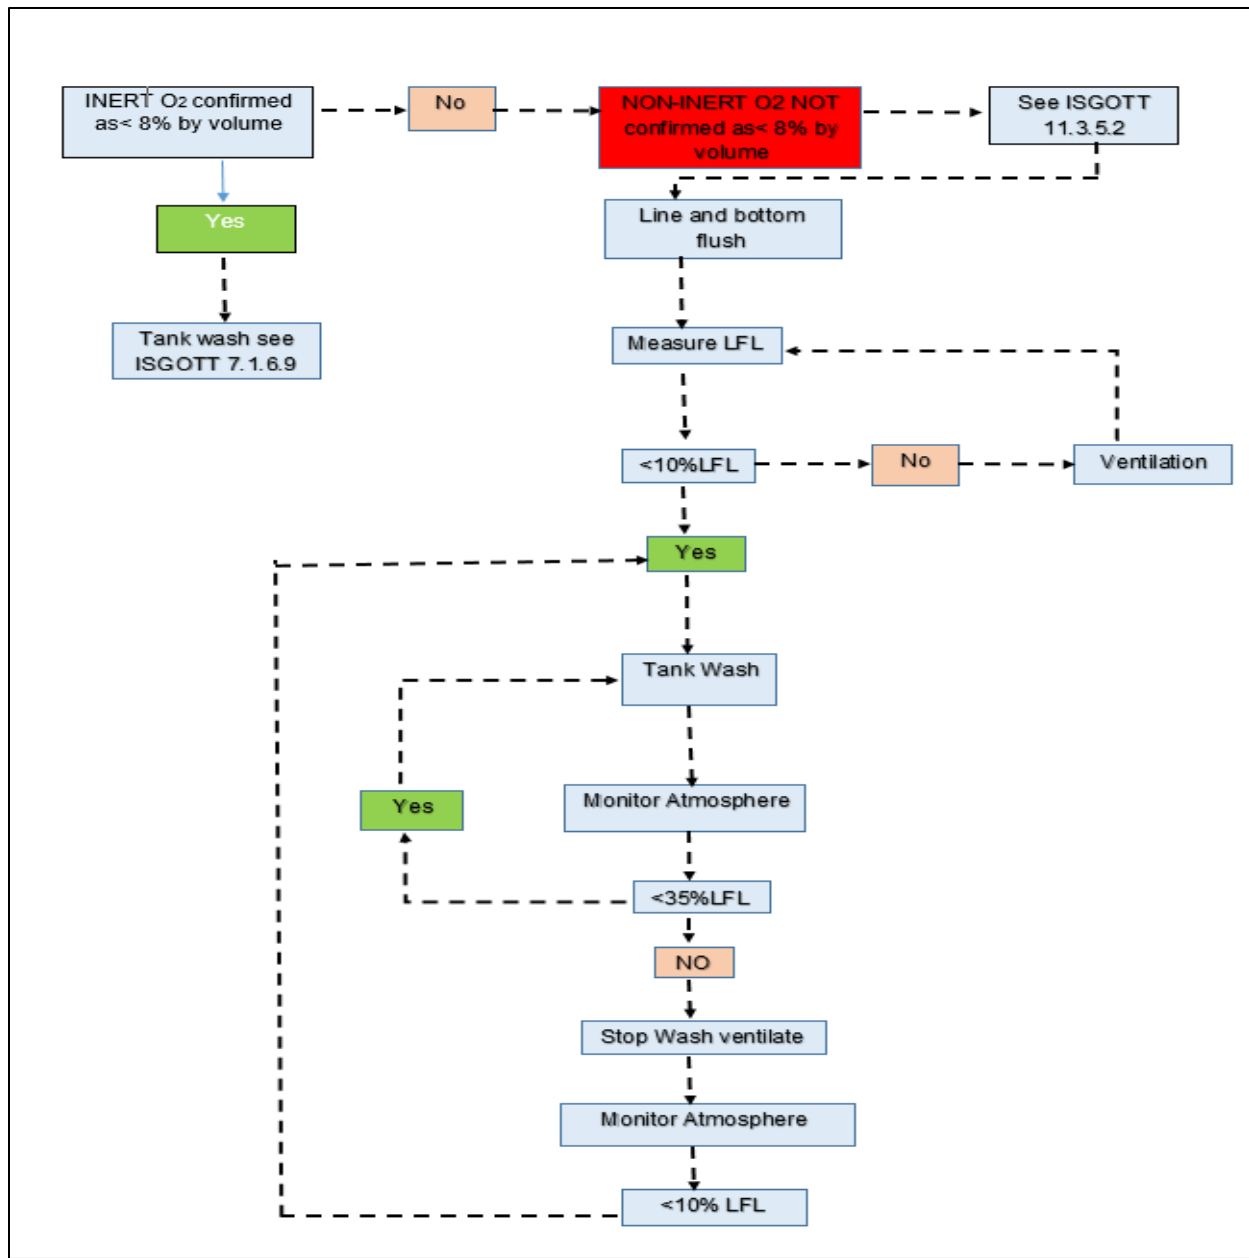
Figure 5: Flow chart showing steps to control the 'fuel' while tank washing in the non-inert tank atmosphere

Tank cleaning guidelines provided in the ISGOTT¹⁰ need to be strictly adhered to. The concept of reducing the HC content to less than 2% volume does not provide an acceptable referral level for any hot work, when cargo tanks are not inerted. A provision of reduction to less than 10% LEL should be maintained. Further, detailed records of such critical operations shall be maintained for future reference where required.

The current washing protocol adopted by vessel, involving 3 cycles for a duration of 45 minutes each should be reviewed to ensure it is adequate for effectively cleaning the Slop Port Tank. It may be beneficial to assess the efficiency of the washing process and determine if more cycles or longer durations are needed to ensure the tank is thoroughly cleaned and free from hazardous residues. After completing the washing cycles, conduct a thorough check to verify that the tank is free of any oil residues, flammable vapors or hazardous gases. This should be a mandatory step before any further maintenance, such as hot work, is carried out to avoid unsafe working conditions.
